Evaluation of beach rehabilitation success, Turners Beach, Tasmania

Elizabeth Johnston · Joanna C. Ellison

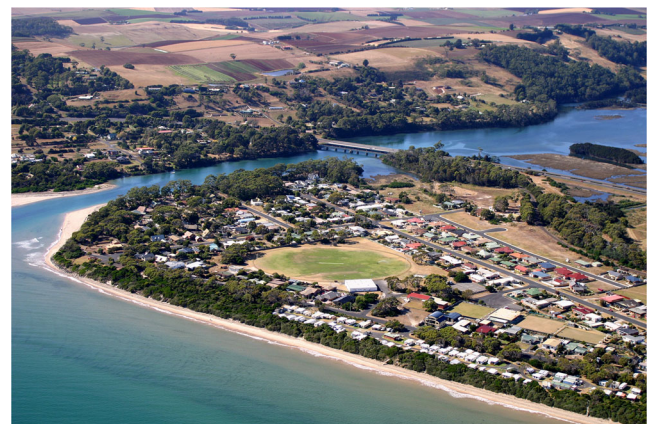
Fig. 1 Oblique aerial photograph of Turners Beach in 2006 (Photo: Daryl Jones)

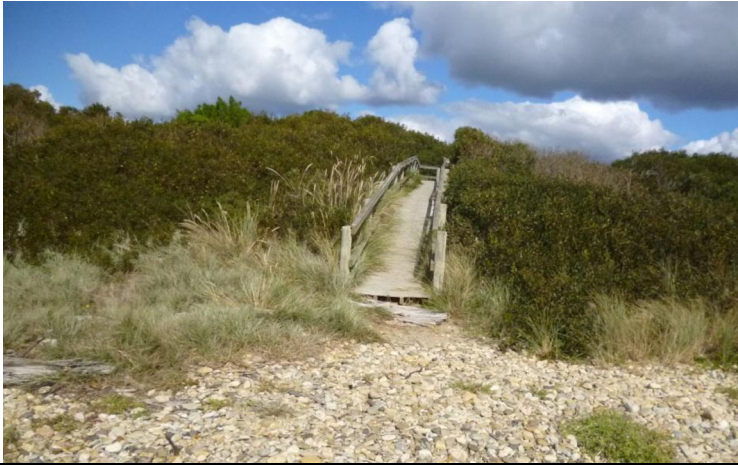
| Action | Dates and Sources | Illustration |
|---|--|--|
| Timber beach access walkways were installed at 7 locations along Turners Beach with the aim of directing foot traffic across a reinforced track, and minimising human trampling on the dunes. | Photo 2012 Turners Beach Coastcare Group Central Coast Council 2011 | |

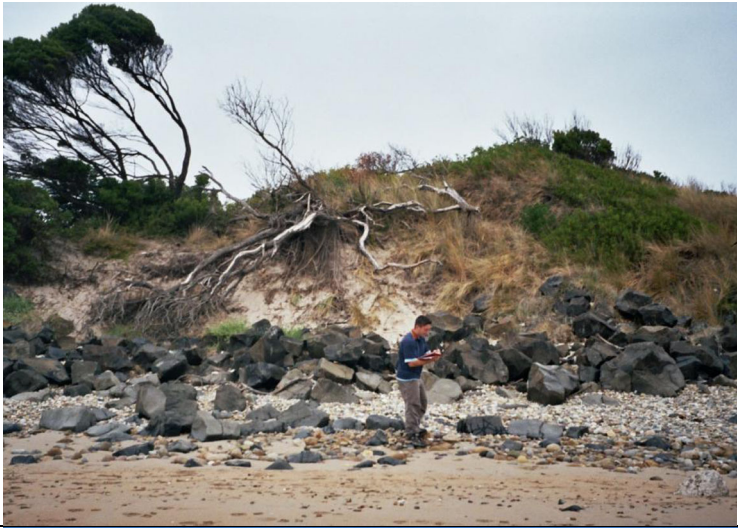
| Action | Dates and Sources | Illustration |
|---|--|--|
| Rocks were installed on two beach sections in an attempt to protect the primary dunes from erosion. | Photo 2002 Initially 1990s, and one section was extended in 2006. Central Coast Council 2011 | |

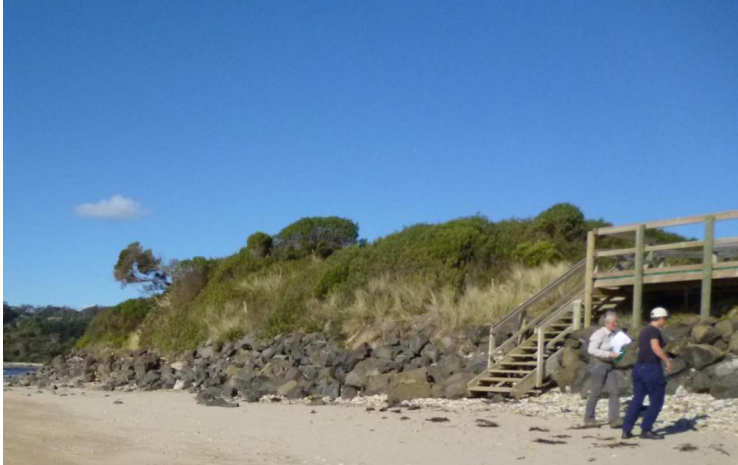
| Action | Dates and Sources | Illustration |
|---|--|--|
| Native revegetation performed at many sections, including around the public beach walkways, foreshore reserves, and where the rocks were placed | Photo 2012 Ongoing from 1998 Turners Beach Coastcare Group | |

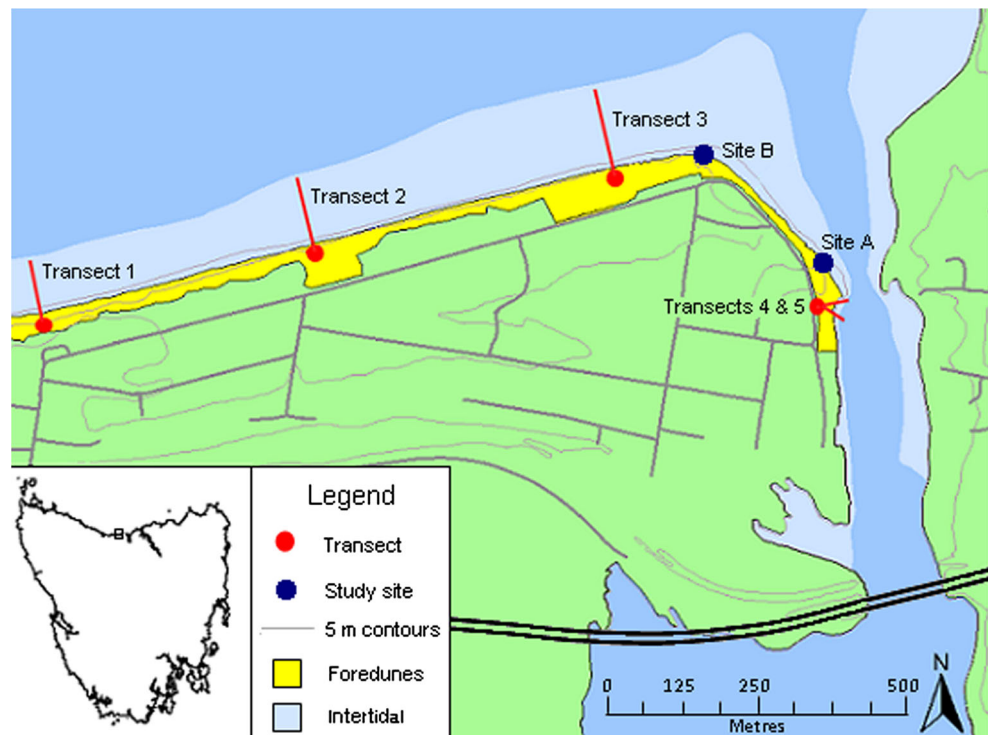
Fig. 2 Map of Turners Beach, showing locations of transect profiles and sites mentioned in the text (Adapted from DPIWE 2012)

surveyed. Five beach profiles with previous data were available, three along the main seaward beach and two within the Forth River mouth (Fig. 2). Three sites on the main beach were previously measured by the Tasmanian Shoreline Monitoring and Archiving project (TASMARC) (Antarctic Climate and Ecosystems Cooperative Research Centre 2013) in 2006, 2007 and 2010, along with an additional measurement in 2011 for the western TASMARC site. Two transects positioned near the mouth of the Forth estuary were measured 10 years previously by the second author. Each transect was re-surveyed using a Topcon GTS-303 Total Station, the profile extending from the top of the foredune to the low water section of the beach.

Five beach profiles were surveyed during this study (Fig. 2), three at 500 m intervals on the seaward beach with data back to 2006, and two inside the estuary mouth with data back to 2002. Results are described below from west to east.

Transects 4 and 5 inside the Forth estuary mouth had the same starting point but different orientations (Fig. 2). The beach at this site was predominantly sand, with a combination of shingle and sand towards the seaward end of each transect. In addition, shingle was present on the backshore of Transect 4. Vertical poles to prevent vehicle access to the upper primary dune were present along the side of the road above this site (Table 1), beach access was across a wooden staircase constructed in 1998, at which time dunes were revegetated with native species by a Coastcare project. Survey results (Figs. 6 and 7) showed stability of the foredune 2002–2012 across the first 3 m of each profile, but a loss of sand and shingle from the upper beach 2002–2012 of about 1.5–1.8 m, and even more loss at lower intertidal levels. The beach profiles however remained convex.

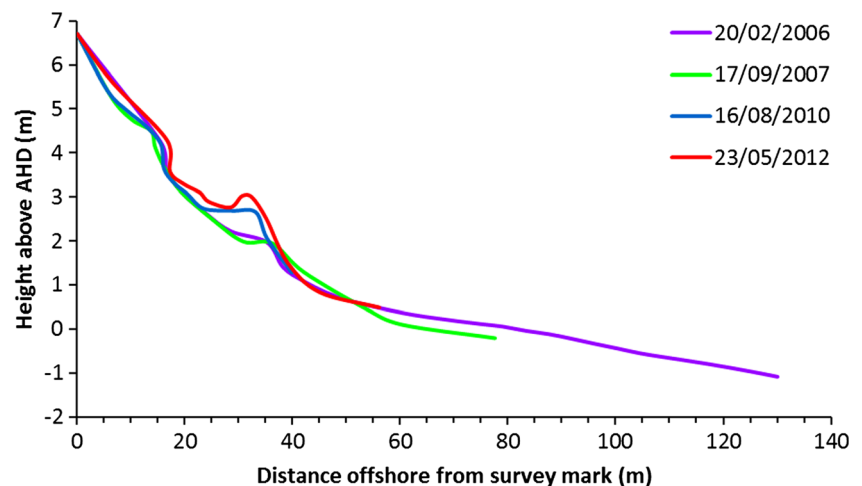
Fig. 3 Beach profile surveys at Transect 1, Turners Beach (VE × 7)

The beach at Transect 1 (Fig. 3) consisted of upper intertidal shingle and lower more level intertidal sand, separated by swash-backwash sorting. Public access through the dunes is by a single boardwalk, with dense native revegetation either side. The foredune was covered with dense vegetation, and no erosion scarp was evident. Previous transect surveys indicated erosion of the foredune 2006–2007 losing about 7 m^2 of sand from the profile, followed by re-deposition 2010–2011, returning the foredune to the 2006 position, and the primary dune showed accretion 2006–2012.

Beach profiles on the seaward facing beach (Figs. 3, 4 and 5) showed a narrow beach and swash zone, lacking bars and cusps but featuring gravel deposits both on the beach and in dunes behind. Beach profile re-measurement over time demonstrated different trends, with Transects 1 and 2 both showing accretion of a foredune between 2.0 and 3.5 m above MSL over the period 2006–2012 (Figs. 3 and 4), changing the overall profile from concave to convex. Prograding beaches are generally convex, often accompanied by developing berms or beach terraces, and the building of foredunes above the high tide level (Bird 2008). Since 2006, the elevation of upper beach shingle has increased by 0.7–1.0 m at Transects 1 and 2 (Figs. 3 and 4). For a 10 m stretch of beach, this would result in an increase in sediment volume of approximately 55–80 m³.

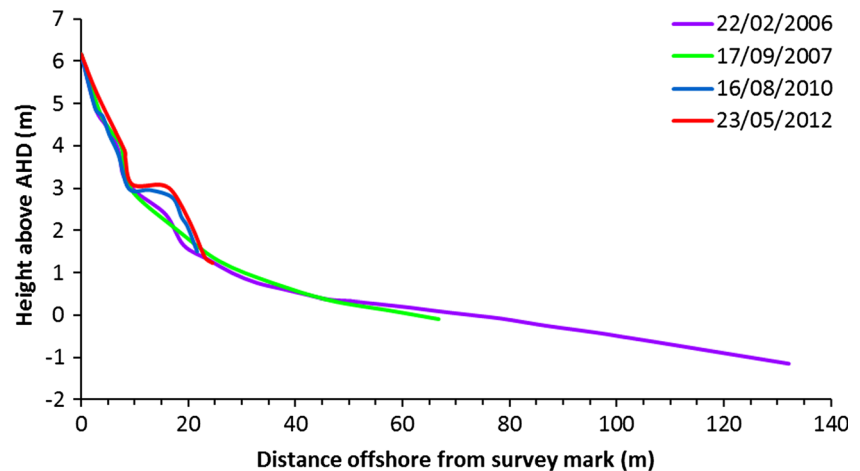
Fig. 4 Beach profile surveys at Transect 2, Turners Beach (VE × 8)

The beach at Transect 2 (Fig. 4) was similar to Transect 1, with upper intertidal shingle and lower intertidal more level

sand. Public access to the beach at this site was restricted to a single boardwalk, and the foredune was densely vegetated

with no erosion scarp present. Surveys showed a foredune developed from 2007–2012, accreting over 8 m² of sand across the profile, and the foredune behind this also showed accretion (Fig. 4). The 2007 survey indicated a minor decrease in the gradient of the lower sandy beach compared to the 2006 survey.

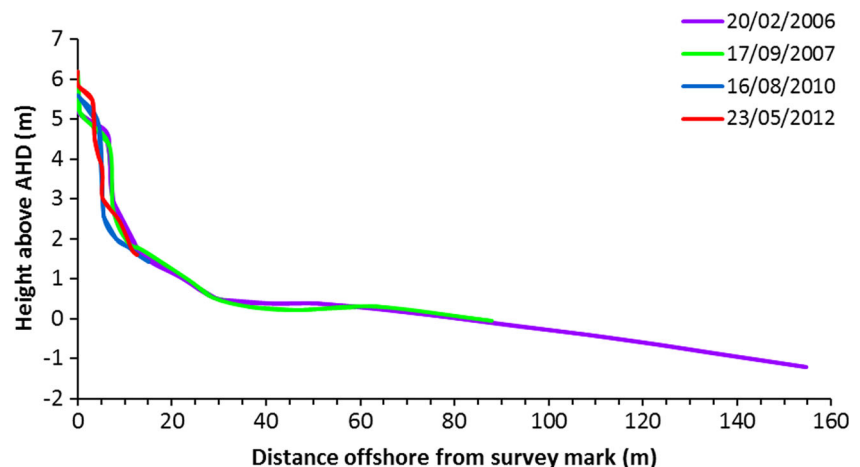
Fig. 5 Beach profile surveys at Transect 3, Turners Beach (VE × 8)

The beach at Transect 3 (Fig. 5) was similar to Transects 1 and 2, with upper intertidal shingle and lower intertidal more level sand. While there was no formal beach access track in the vicinity of this site, an informal track showing signs of current use extended from the road above to the dune top, in close proximity to the survey transect. In contrast to the previous transects, there was a prominent erosion scarp at this site, with exposed roots and fallen clumps of vegetation on the face of the scarp and at the base. Comparison with earlier transect surveys showed a retreat of the foredune of 3 m between 2006 and 2012, however the top of the scarp experienced accretion of around 65 cm during the same period.

The intertidal beach between 0 and 1 m above MSL showed slight erosion 2006–2010, however this was balanced by accretion 2010–2012 (Fig. 5).

By contrast, the eastern section of Turners Beach and the shoreline within the Forth River mouth were shown to have eroded (Figs. 5, 6 and 7), with Transect 3 showing an increasingly concave profile over time (Fig. 5), with continuing dune front retreat with an active dune scarp of around 2.5 m high with a gradient of greater than 30°, where the strength of unconsolidated sediments is reduced (Nichols 2009). For a 10 m stretch of coastline, this erosion would result in a loss of sediment of approximately 75 m³ in volume.

installed (Table 1) to help reduce pedestrian access over the dunes, a similar intention to walkways. However, while dune fencing was perceived as being successful by 50 % of respondents to the survey it was viewed as unsuccessful by 17 % (Fig. 10). Fencing has contributed to success at Site 2 (Fig. 9), with growth of dense foredune vegetation and disused informal access tracks. However, some of these fences are in a state of disrepair, allowing for a small number of informal beach access tracks to remain in used, causing erosion of the upper beach of around 3 m since 2006 (Fig. 5).

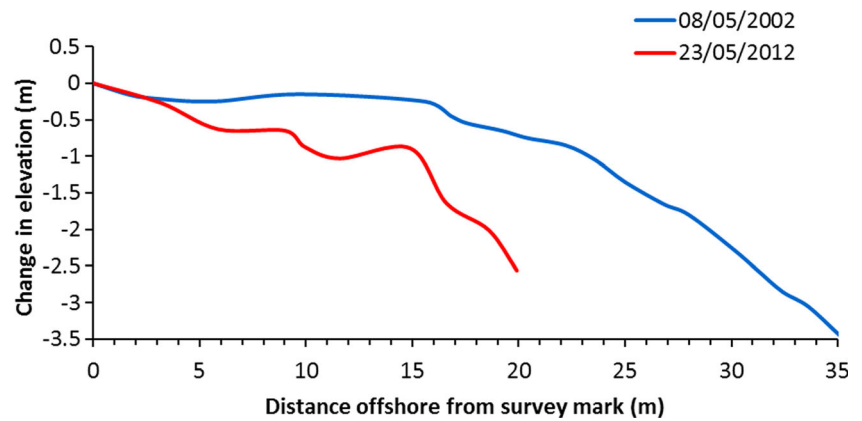
Fig. 6 Beach profile surveys at Transect 4, Turners Beach (VE × 3)

Beach profiles within the mouth of the Forth River (Figs. 6 and 7) showed steep convex profiles with stability in the frontal dunes. Loss of sediment from the profile that occurred 2002–2012 was from truncation of the lower intertidal beach, and a likely explanation is channel movement in the lower estuary associated with river floods.

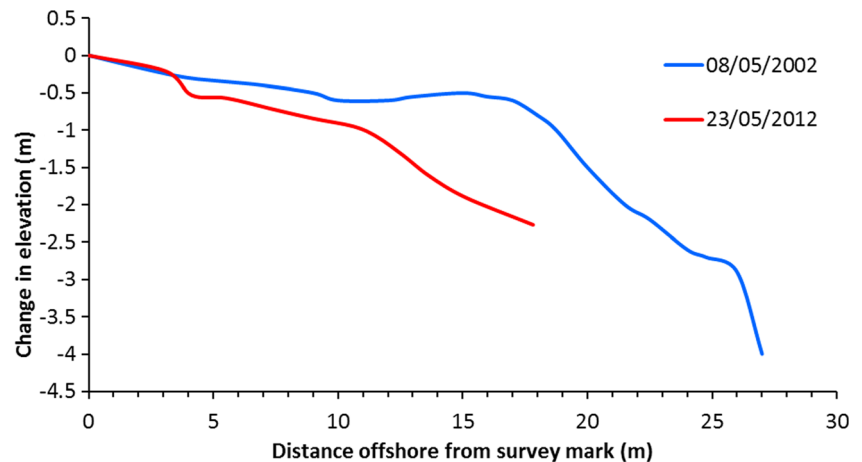
Fig. 7 Beach profile surveys at Transect 5, Turners Beach (VE × 3)

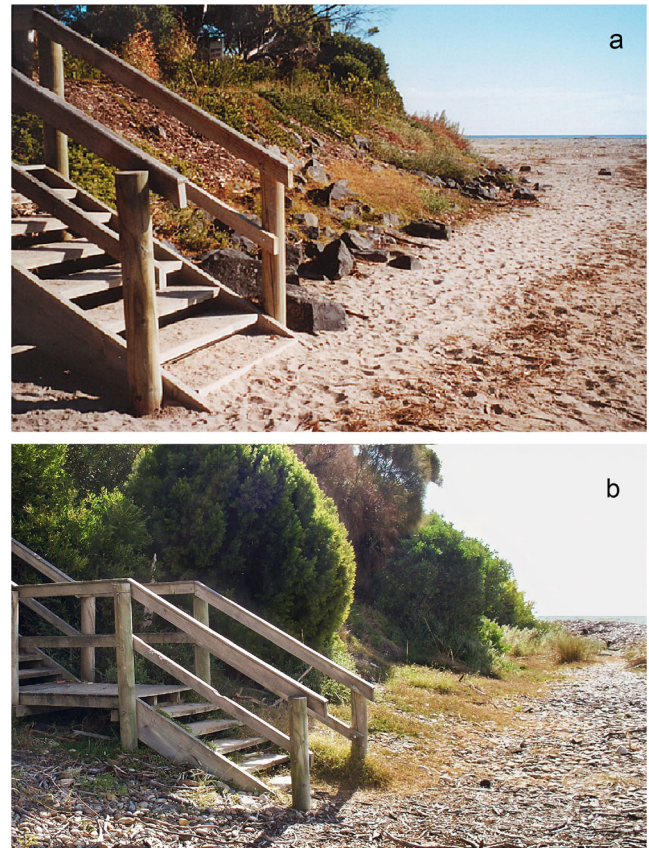
Fig. 8 Public staircase and dune revegetation at Site A. **a:** 2002 (Photo: J. Ellison), **b:** 2012 (Photo: E. Johnston)

Site A is located adjacent to Transects 4 and 5 (Fig. 2), close to the mouth of the Forth estuary and dune erosion was evident in the 1990s largely as a result of human access and trampling. In 1998 the Coastcare group project installed a public staircase leading from the road behind to the beach, erected a fence to limit public access outside of the staircase, and placed rocks along the shoreline to prevent undercutting of the dune. The

primary dune was subsequently revegetated using native plants by the Turners Beach Coastcare volunteers.

Comparison of the 2002 historical photograph with 2012 observations of this section (Fig. 8) showed accretion of sand and organic matter over the rock area, such that in 2012 the rocks were barely visible (Fig. 8b). In addition, the dune is now largely covered with coastal grass and shrubs (Fig. 8b), and accretion of the backshore has occurred with the bottom two steps of the public staircase at the backshore becoming covered by shingle/sand deposits (Fig. 8b).

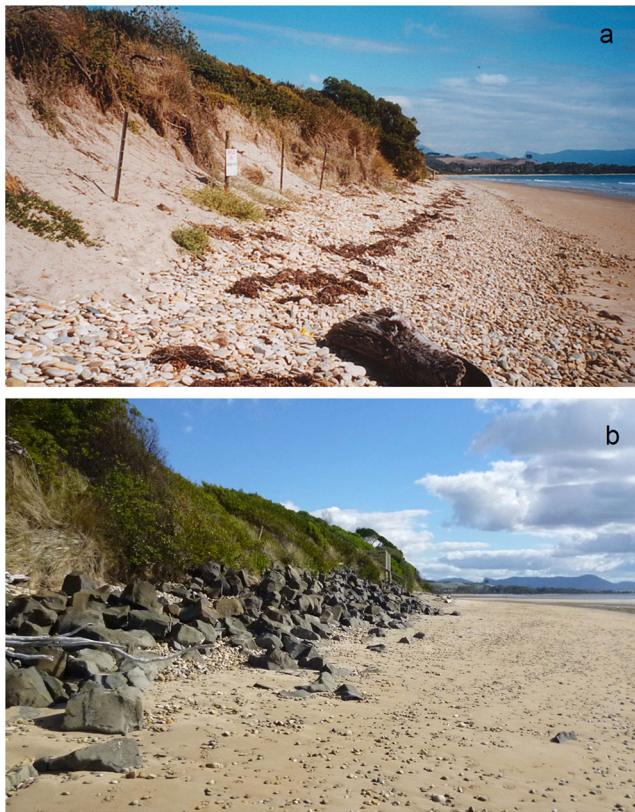
Fig. 9 Erosion at Site B at the eastern end of Turners Beach. **a:** 2002 (Photo: J. Ellison), **b:** 2012 (Photo: E. Johnston)

Site B is located on the eastern end of Turners Beach (Fig. 2) and has been eroding over the last several decades, particularly as a result of a storm in 1995. In 1998 large rocks were placed on a section to the east (Table 1), and more rocks were placed towards to the west in 2006 (Fig. 9), along with a public walkway and staircase constructed for public access to the beach from the road behind (Table 1). The dunes were also revegetated by the Turners Beach Coastcare volunteers, and the top of the dunes fenced with signage to prevent access (Table 1).

Comparison of 2002 historical photographs with 2012 observations of this section showed integration of shingle with

the installed rocks, and dense vegetation developed on the upper dune (Fig. 9b). In addition, the dune scarp erosion evident in 2002 (Table 1) had recovered by 2012. However, in 2012 some of the dune top fences were in a state of disrepair, and informal beach access tracks were still in use.

The placement of rocks along the shoreline to increase lower dune resilience to erosion appears to have had mixed success. At the eastern end of the beach (Fig. 9), they appear to have been effective at promoting accretion of the upper shoreline with shingle integrating with the rocks, and sand and organic matter now covering rocks (Fig. 8). However, the success of rock placement was met with mixed views by survey respondents. While 50 % of respondents believed the erosion was reduced at the locations at which the rocks were placed, several expressed concerns that the rocks may be deflecting erosion to the shoreline adjacent. At Site B, revegetation of the dune scarp above rock reinforcement has occurred (Fig. 9), however the adjacent Transect 5 (Fig. 5) shows no accretion over the same time period. Installation of hard coastal protection structures can lead to wave refraction and an increase in erosion of the adjacent shoreline (Lumsden 1995), which appears to be occurring at Turners Beach. Community surveys regarding coastal erosion in Latvia showed similar results, with half of the interviewees considering hard coast
